Service Bulletin

SUBJECT: Special Coverage Adjustment – Transmission Clutch Wave Plate

MODELS: 2007-2009 Buick Enclave
2008-2009 Chevrolet Equinox, Malibu
2009 Chevrolet Traverse
2007-2009 GMC Acadia
2007-2009 Pontiac G6
2008-2009 Pontiac Torrent
2007-2009 Saturn AURA, OUTLOOK
2008-2009 Saturn VUE
Equipped with FWD or AWD and 6-Spd Automatic Transmission
(RPO MH2, MH4, MH6, or MY9)

Subject: 14404B – Special Coverage Adjustment
Transmission Clutch Wave Plate
Vehicle Population Added

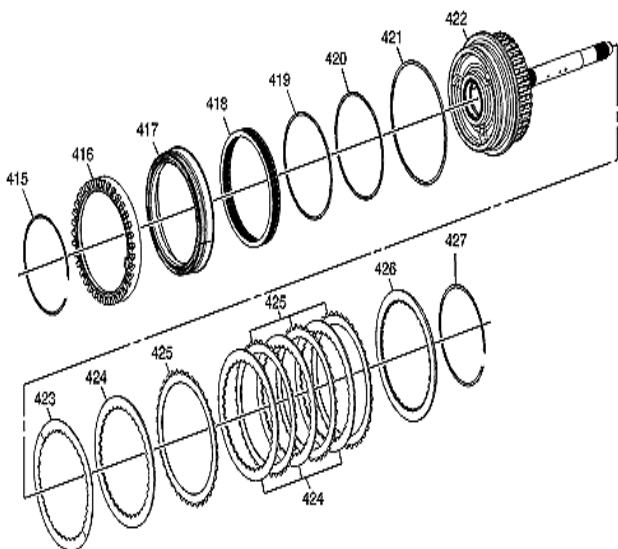
2584818

Note: Debris generated by the condition must be cleaned from the entire transmission and the pump fluid filter (201) and the control solenoid filter plate (16) must be replaced. Failure to separate the case halves, disassemble the transmission, clean the debris and replace the pump fluid filter (201) and the control solenoid filter plate (16) could lead to repeat transmission damage and repairs.

A broken 35R wave plate can generate varying amounts of debris inside the transmission. In most cases this debris has not passed through the pump fluid filter (201) potentially damaging the pump, valve bodies or torque converter. This debris can be cleaned and the transmission successfully repaired.

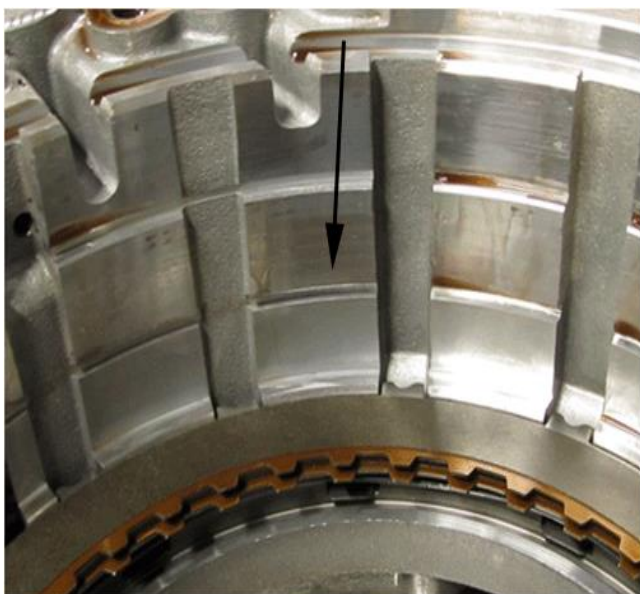
2753502

- The snap ring groove, which is well below the 3-5-R wave plate area, is unlikely to be damaged. It should still be checked to verify the snap ring is fully seated and to be securely retained.

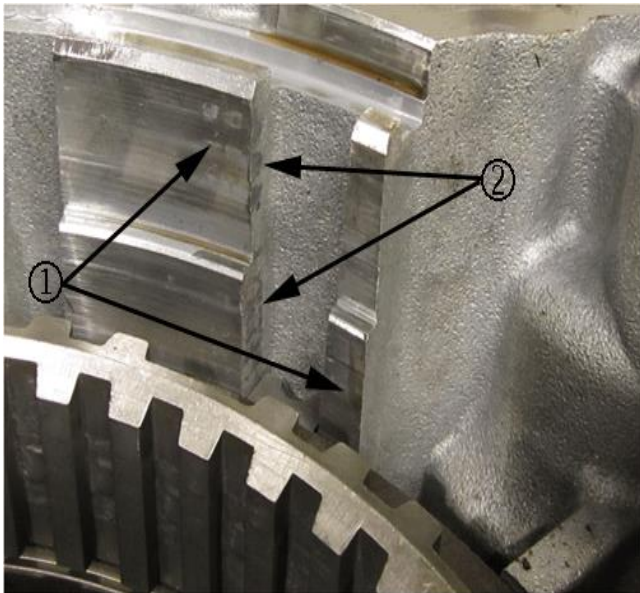
2753503

- Peening or wear of the face or edge of the case lugs that engage the steel clutch plates is normal and not cause for transmission replacement.

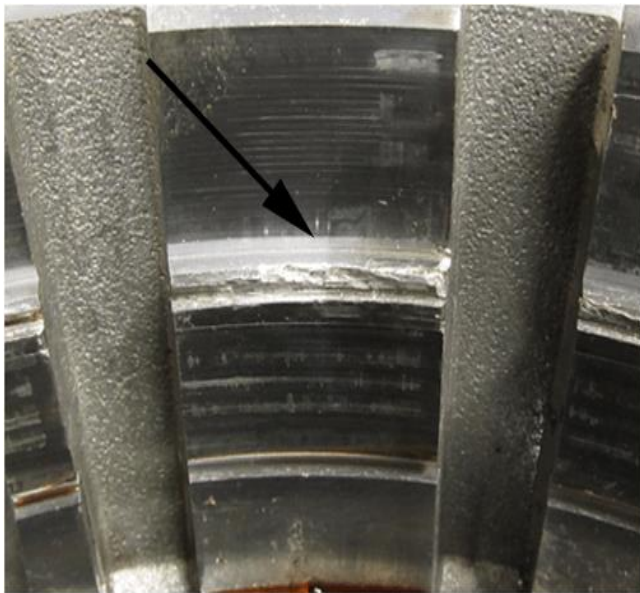
2753509

- Some degradation of the shelf for the 2-6 backing plate is acceptable as long as the plate can lie flat. A raised burr that prevents this can be removed using a de-burring tool, file or some other abrasive.

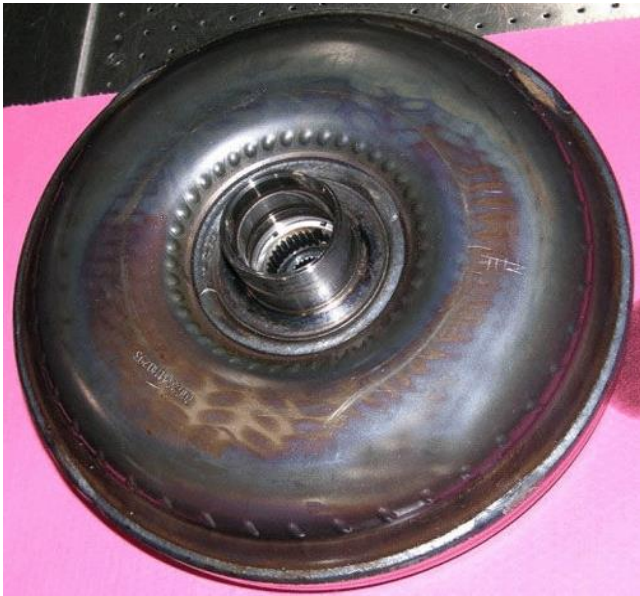
2739303

Note: The manufacturing process of the torque converter can cause the hub side to appear blue or darker in color while the lug side is a natural metal color. If the torque converter appearance is like this and no other reason is observed per the SI procedure for torque converter diagnosis, then the torque converter does not need to be replaced.

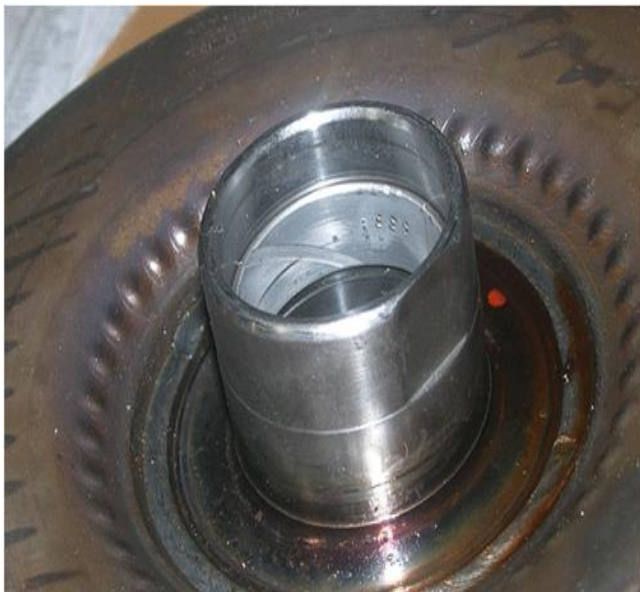
2753510

Marks such as these on the torque converter bushing are not a reason to replace the torque converter. They usually occur during removal of the transmission from the vehicle or removal/installation of the torque converter on the transmission and are caused by the bushing contacting the front differential transfer drive gear support (208) or the 3-5-R housing (422).

Also the marks are below the surface of the bushing and will not interfere with proper operation, however if there is a raised burr it can be removed with a de-burring tool or other abrasive.

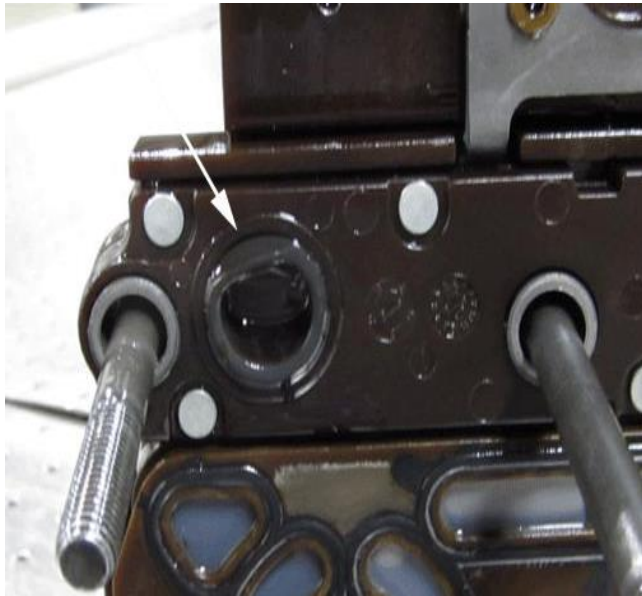
2850322

6. Inspect the control solenoid (w/body and TCM) valve assembly (TEHCM) (15) pressure switches. The O-ring seals may be deformed but if they are attached, as shown above, the TEHCM should not be replaced; it should be reused. Deformed seals do not affect switch performance.

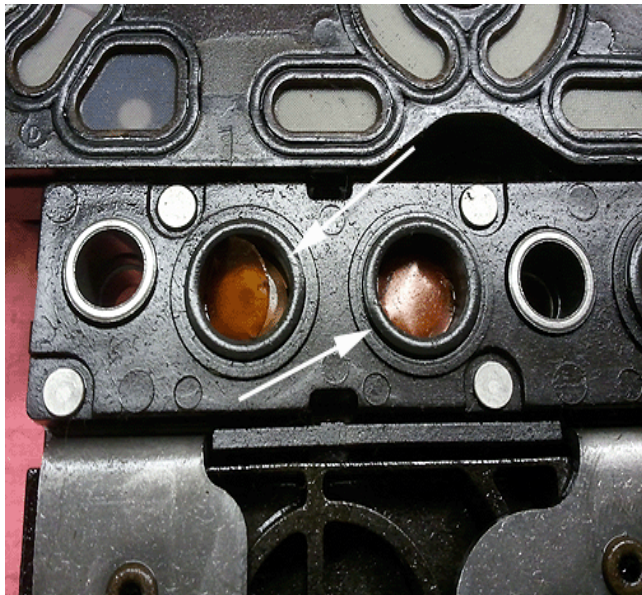
2630114

If any of the switch membranes are damaged, as shown above, the TEHCM must be replaced.

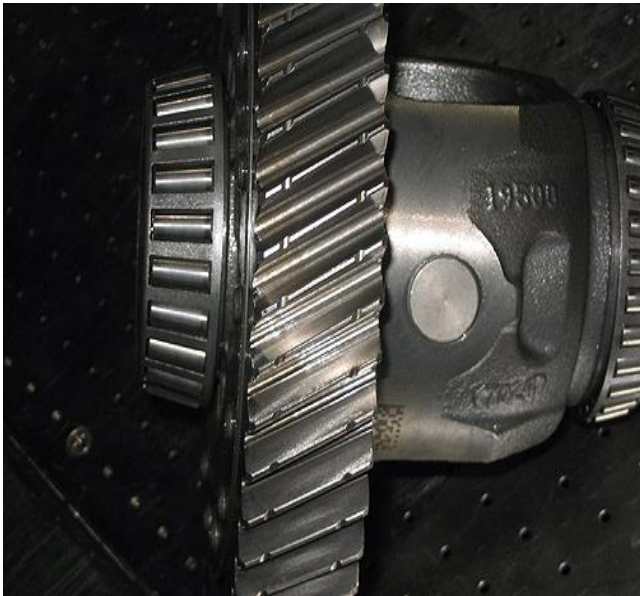
2584822

Note: The front differential carrier assembly (31) teeth are marked with notches to identify gear ratio (see picture above). Do not confuse these marks with tooth damage. Do not replace the gear for this condition.

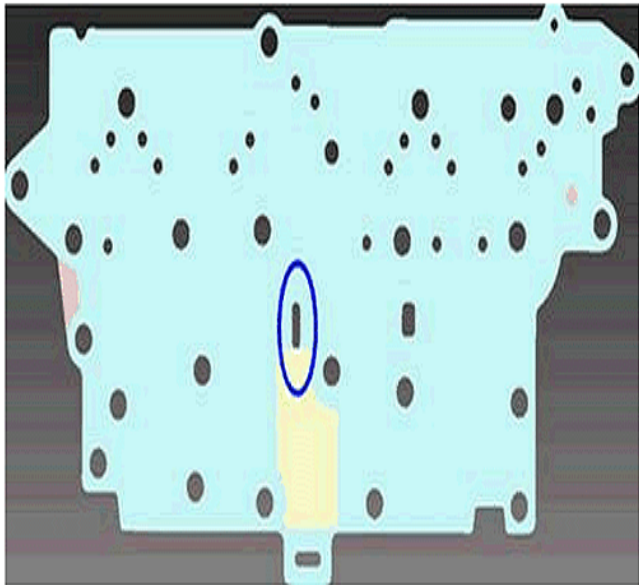
2584820

Note: 2007-2008 applications – when assembling these transmissions, inspect the control valve channel upper plate (301) to make sure that it contains the slot as indicated above. Plates installed that do not include this slot may result in DTCs.
