Service Bulletin

SUBJECT: Special Coverage Adjustment – Transmission Clutch Wave Plate

MODELS: 2007-2009 Buick Enclave
2008-2009 Chevrolet Equinox, Malibu
2009 Chevrolet Traverse
2007-2009 GMC Acadia
2007-2009 Pontiac G6
2008-2009 Pontiac Torrent
2007-2009 Saturn AURA, OUTLOOK
2008-2009 Saturn VUE
Equipped with FWD or AWD and 6-Spd Automatic Transmission
(RPO MH2, MH4, MH6, or MY9)

Subject: 14404B – Special Coverage Adjustment
Transmission Clutch Wave Plate
Vehicle Population Added

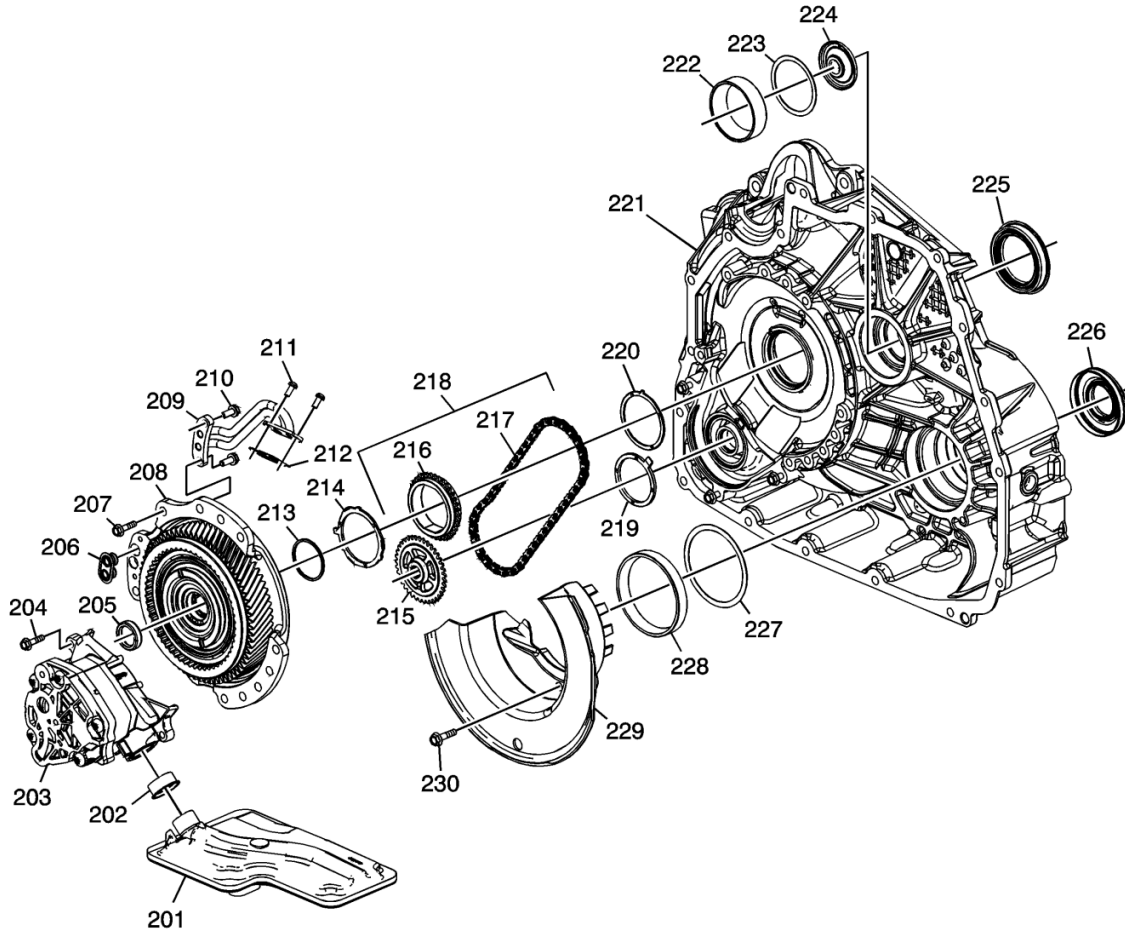
1725882

Note: Debris generated by the condition must be cleaned from the entire transmission and the pump fluid filter (201) and the control solenoid filter plate (16) must be replaced. Failure to separate the case halves, disassemble the transmission, clean the debris and replace the pump fluid filter (201) and the control solenoid filter plate (16) could lead to repeat transmission damage and repairs.

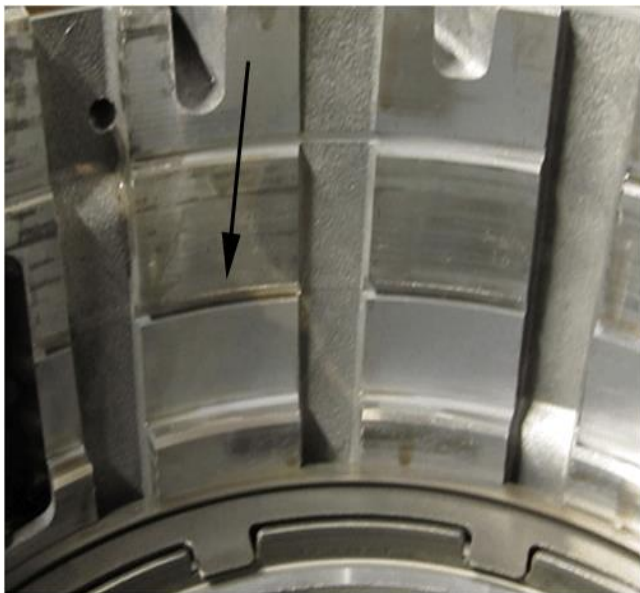
2753500

1. Remove the case cover assembly (35). Inspect the case cover for damage. This part is serviced and can be replaced if it is damaged.
2. Remove the 35R/456 clutch housing assembly (422) and inspect it for a broken 35R wave plate (423).
3. Inspect the case (21) for damage caused by a broken wave plate as shown below.

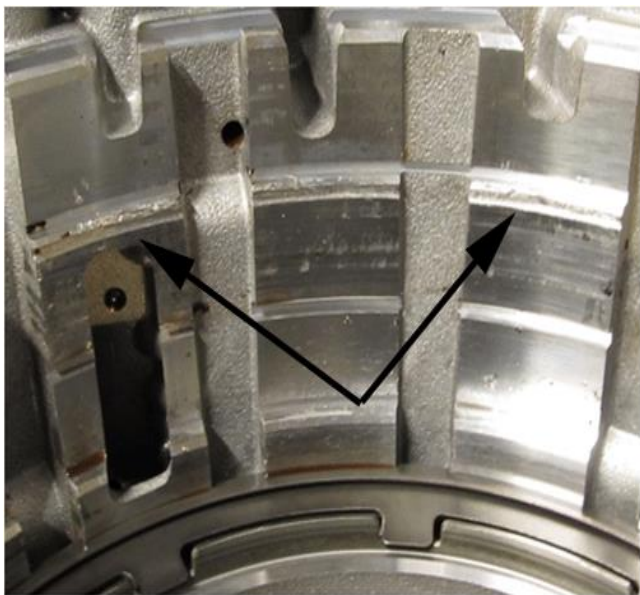
2753506

- Peening or wear of the face or edge of the case lugs that engage the steel clutch plates is normal and not cause for transmission replacement.
